Glass Stairs in Venray

## Constructing Glass

**Interview with: ing. M.C. Taal**  
Engineer at Verhoeven & Leenders

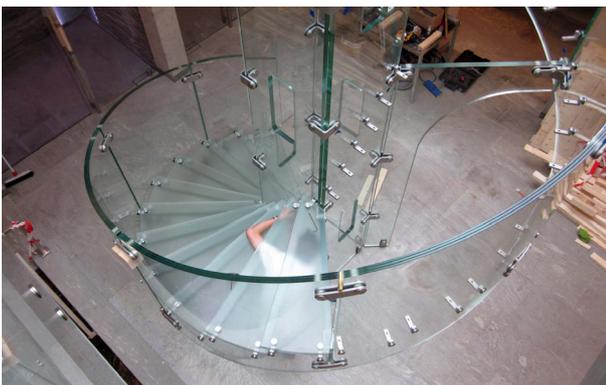
*Figure 1: Supporting L-shaped beam of the side rail.*

prevent too large deformations in the steps. To make the handrail also part of the supporting structure for the steps, three L-shaped beams are connected to the column. One of these beams is shown *Figure 1*. These L-shaped beams are connected to the corners of the column, to ensure an equal vertical loading on each beam. Therefore, the dimensions of the beams are all the same, only the length of the part connected to the column varies.

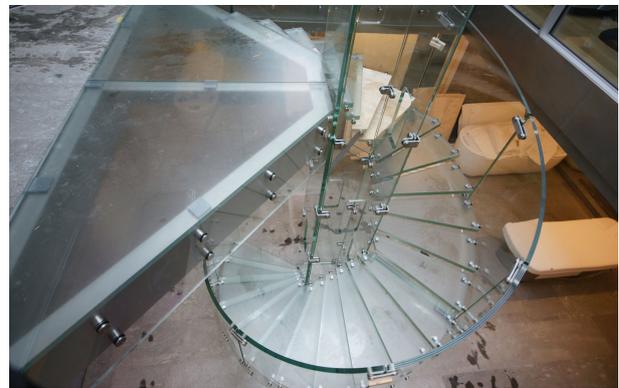
Figure 3: Two steps temporarily made of wood

In conclusion when the stairs is used in a normal way, the expected life time should not be less than a stairs made of any other regular building material. Therefore they expect the stairs to last at least 50 years. In *Figure 3*, the stairs just after completion can be seen. In this photo, two steps made of wood. Those steps had some surface damage which however most likely happened during installation or transportation where impact loads are more likely to occur. With the intended normal use of the stairs this should not happen, which is also the case ever since 2012, after the stairs was completed, no steps have failed. ◀
